Odd Fellows Hall / Old Town Hall

800 New Hampshire Route 140, Gilmanon Iron Works, NH 03837

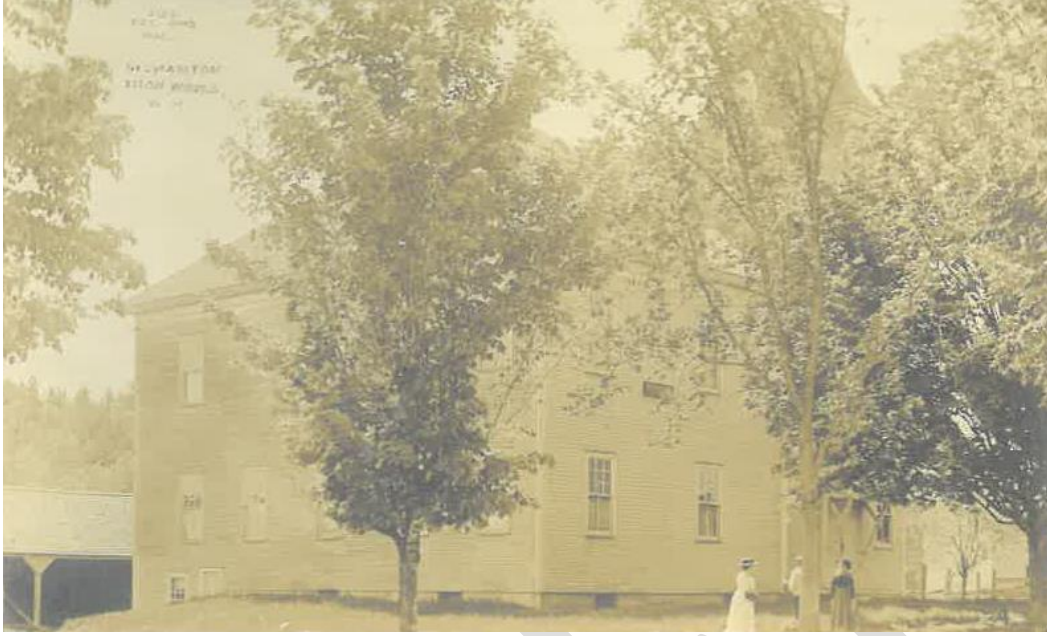
Early 1900's postcard
with horse shed in left background

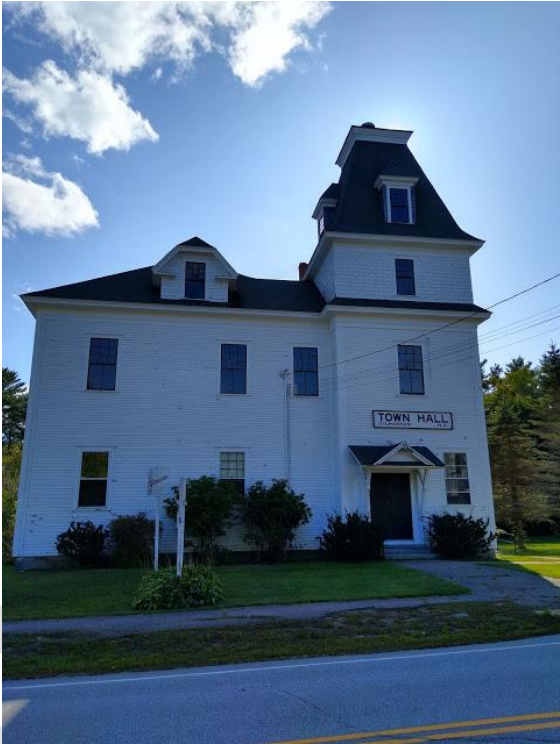
Part 3 Existing Conditions

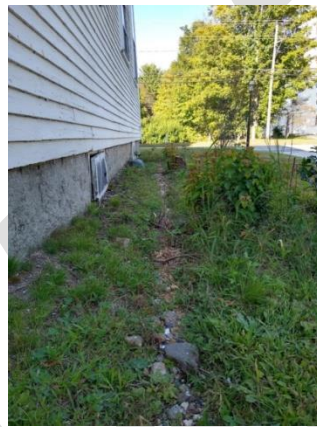
Drip line with negative grade on east side of main building

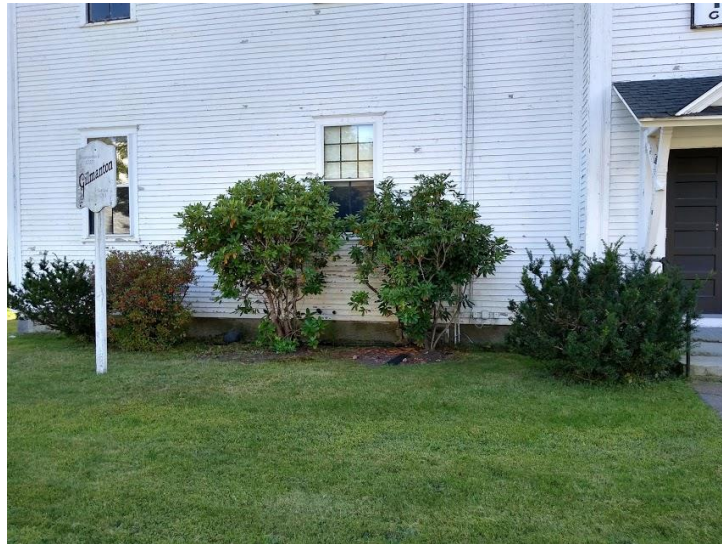
North side overgrown trees and shrubs

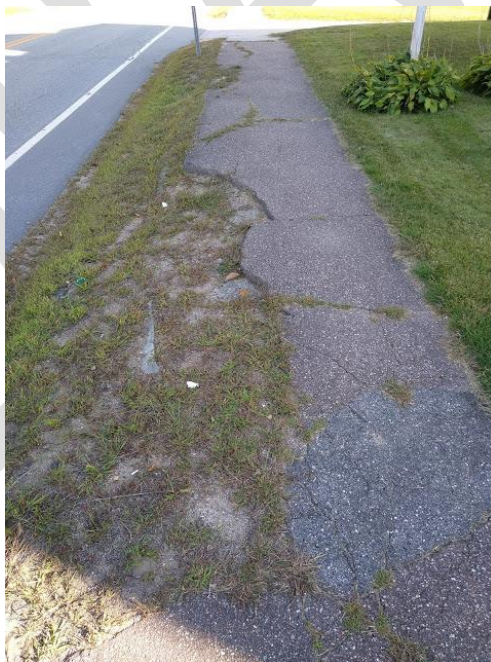
Deteriorated asphalt sidewalk

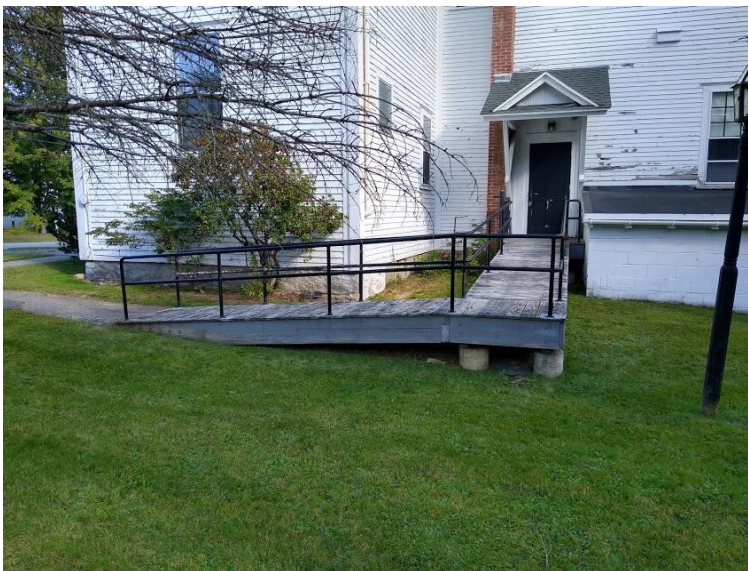
Early 1990's first floor ADA ramp

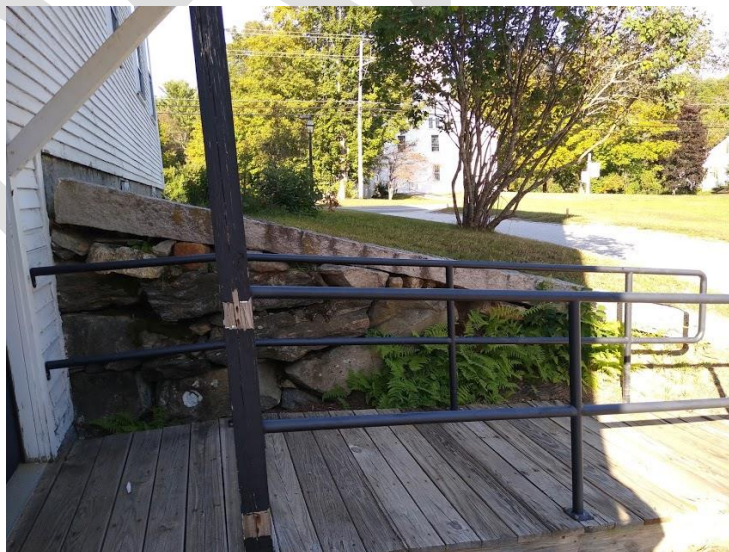
East side lower level ADA ramp

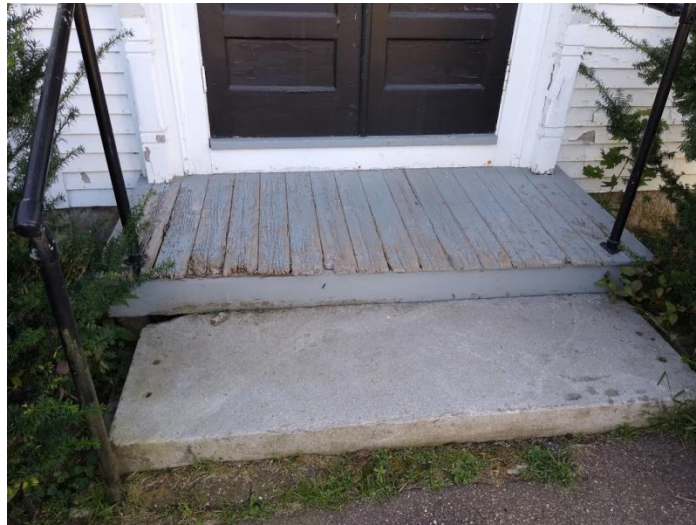
North side main entrance deck

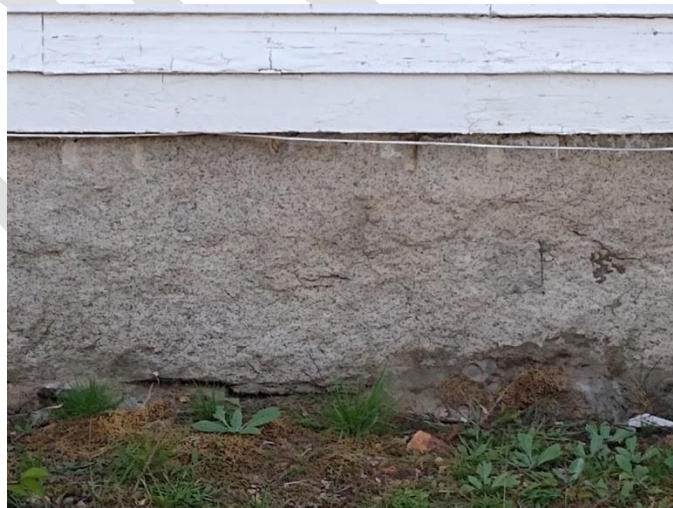
Split cut granite east side

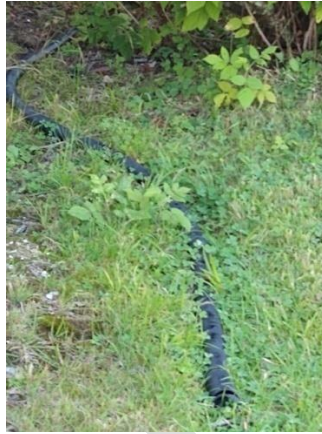
North side sump pump discharge hose

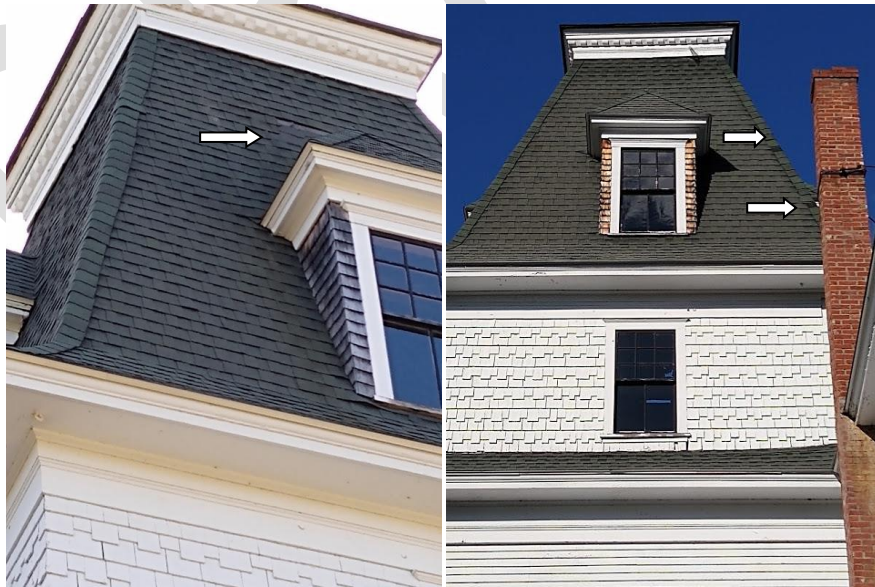
North side of tower missing shingles

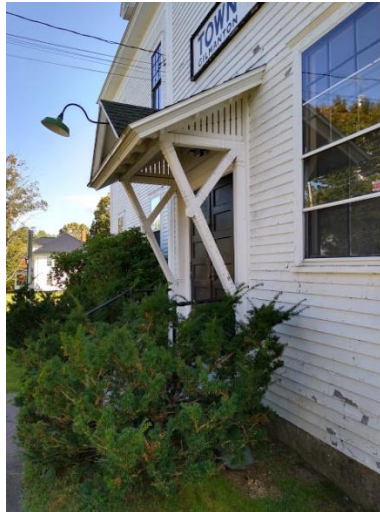
Main entry roof system

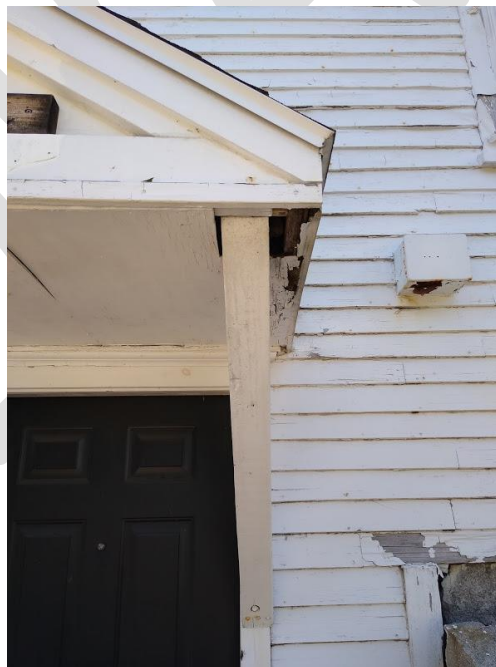
Lower level ADA entry roof system

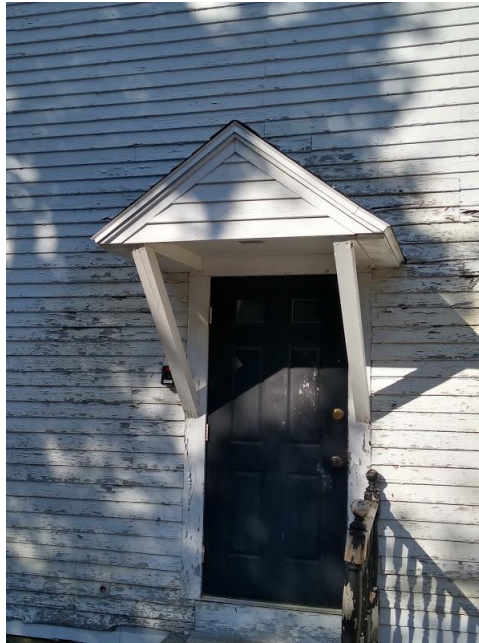
South entry roof system

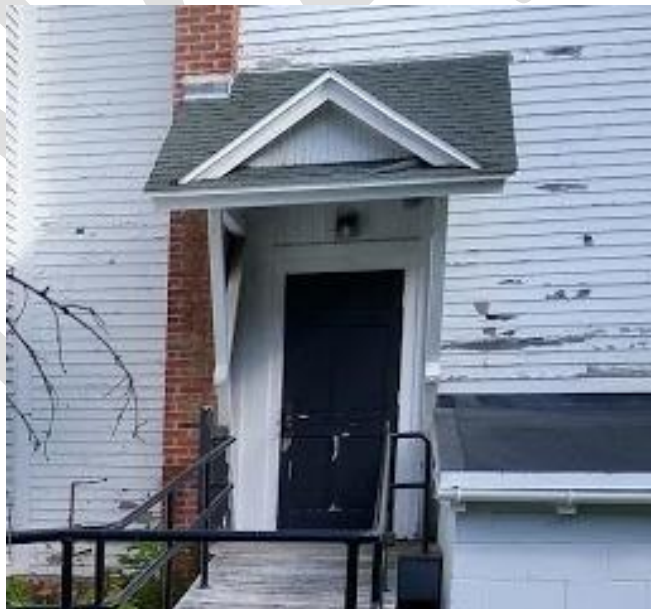
West side ADA entry roof system

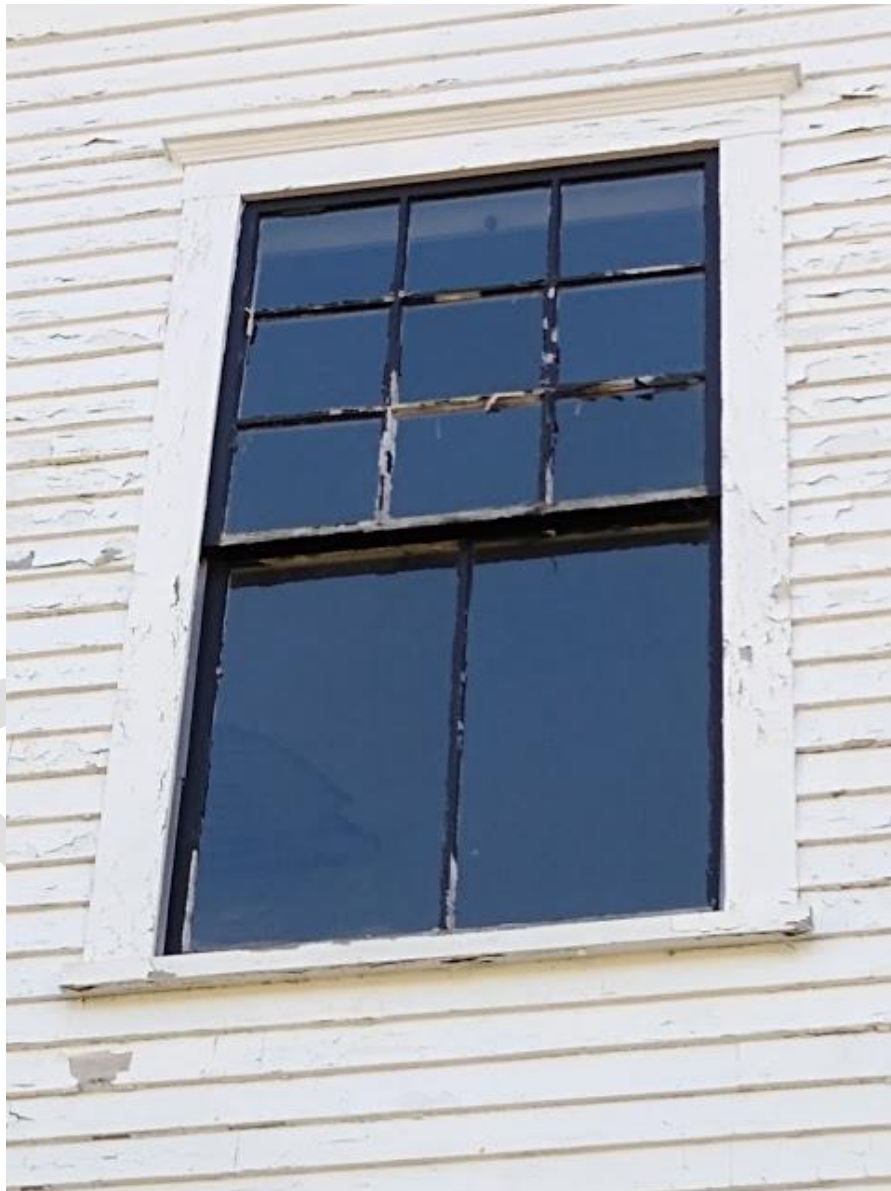
East 2nd floor window indicative of all window conditions especially 2nd floor, dormer and tower windows

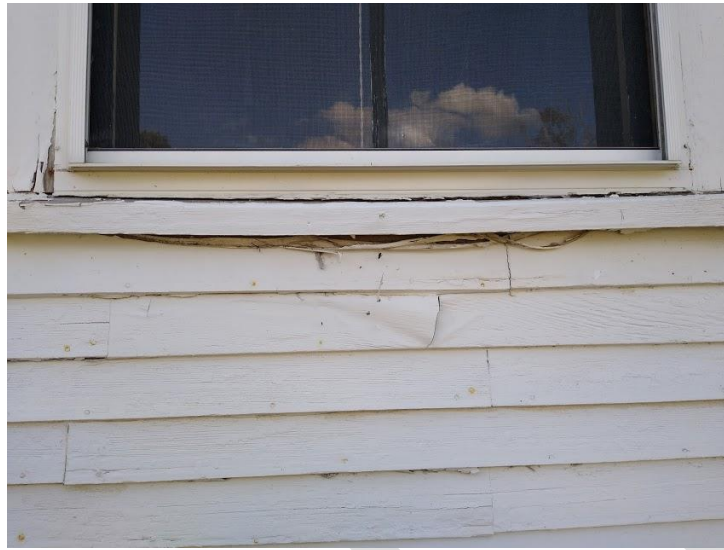
Deteriorated East side 1st floor window sill

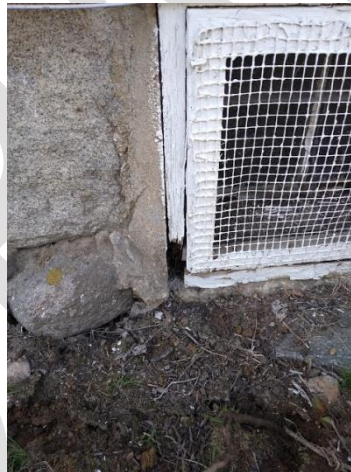
East side rotted basement sash frame

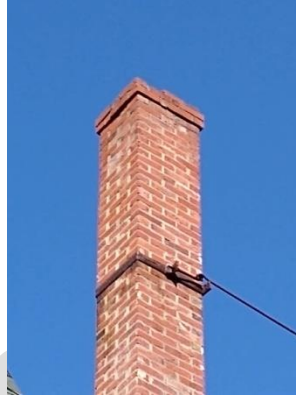
West side chimney with metal brace

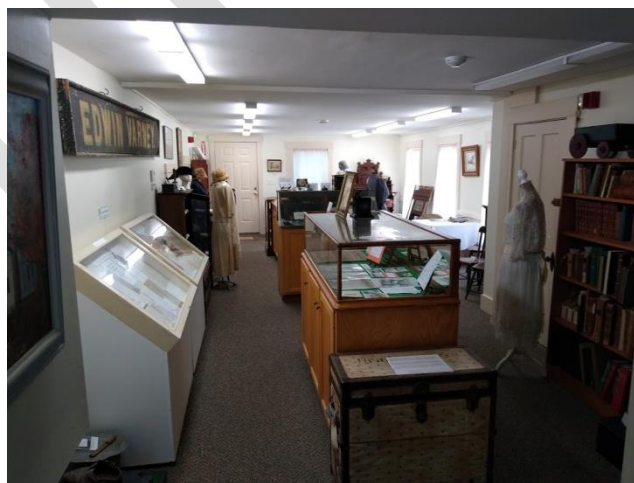
Gilman Historical Society Museum

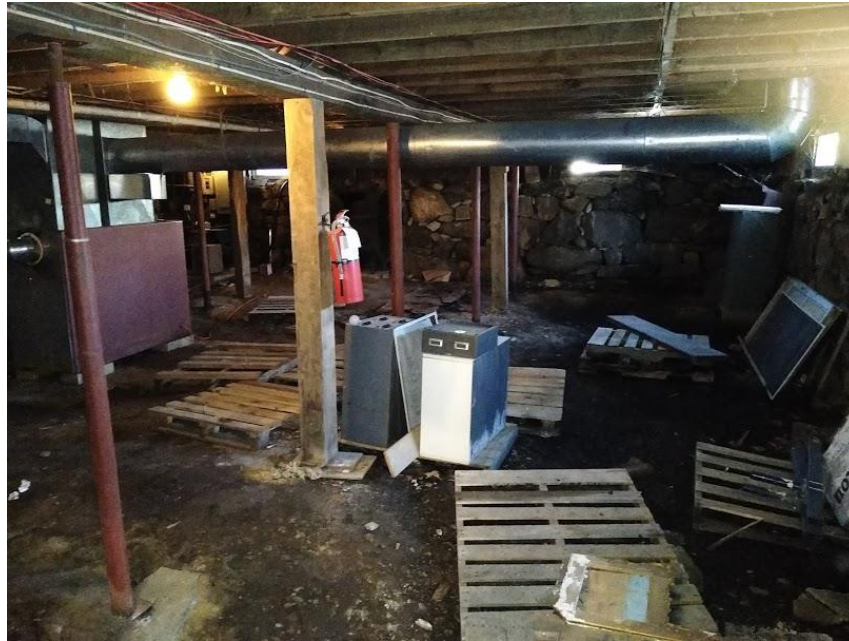
Mechanical space in basement

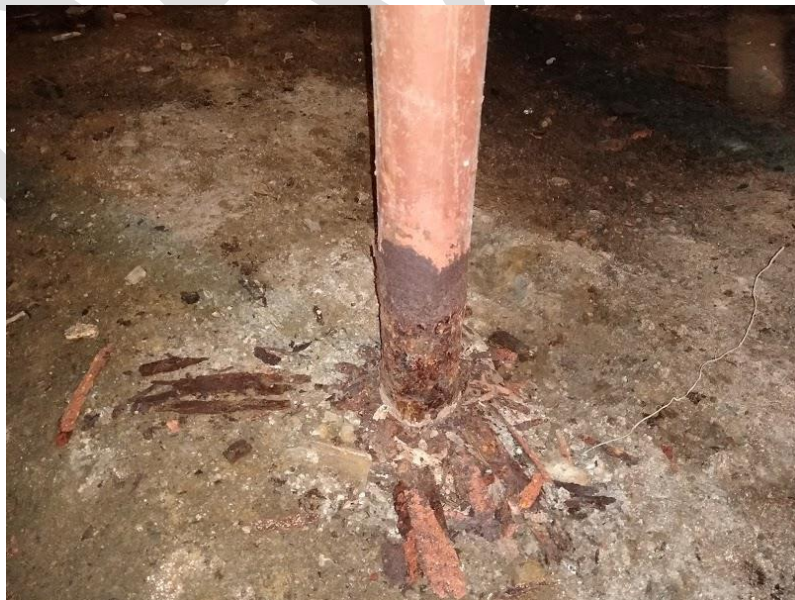
Metal column rot at base

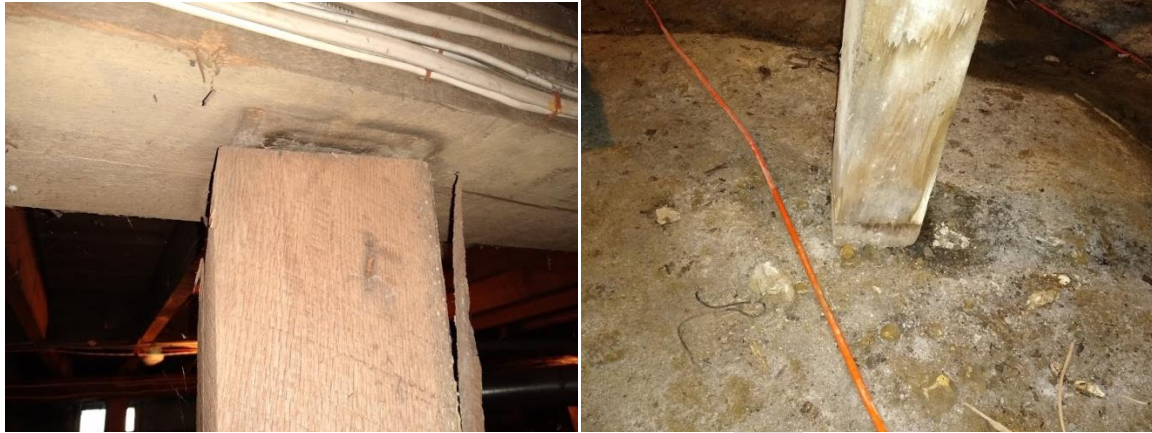
Wooden post no longer providing support for main carrier above with rotted base

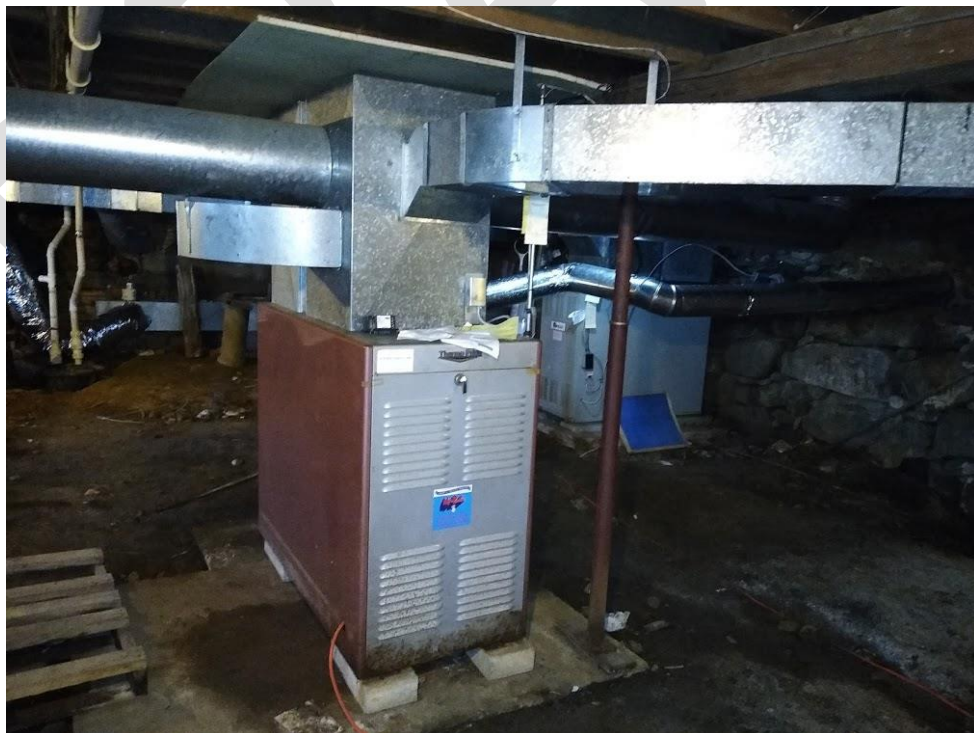
Existing hot air furnace that provides heat to the 1st floor

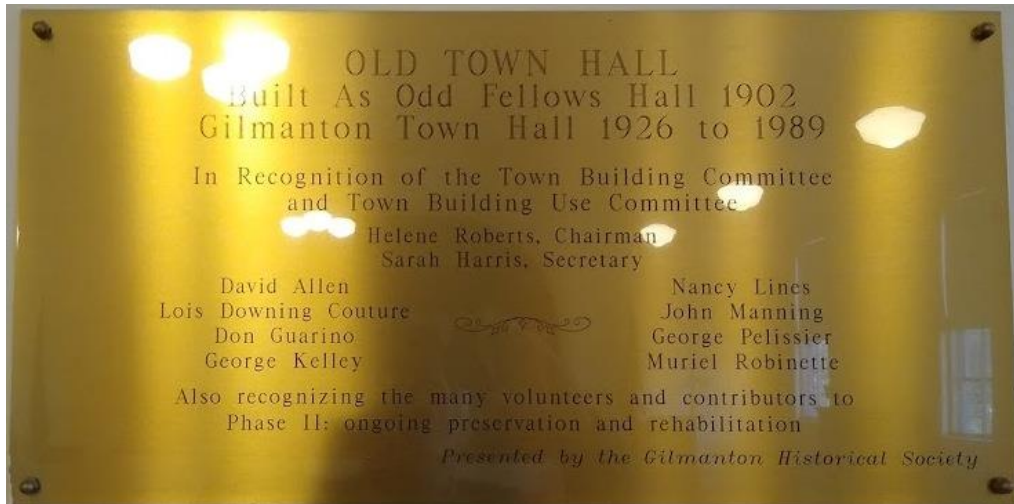
Early 1990's Auditorium plaque in recognition of work on the building

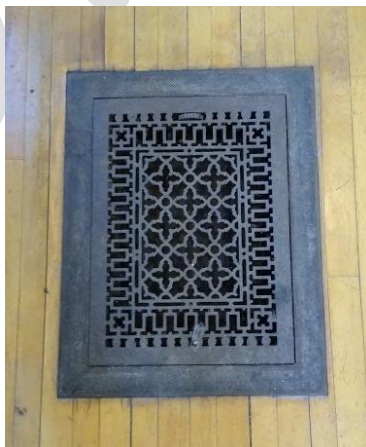
Close up of original hot air grate

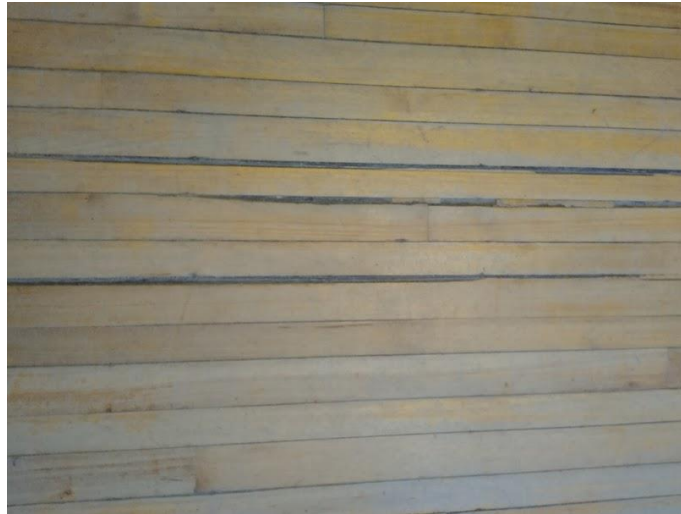
Section of auditorium flooring showing wear.

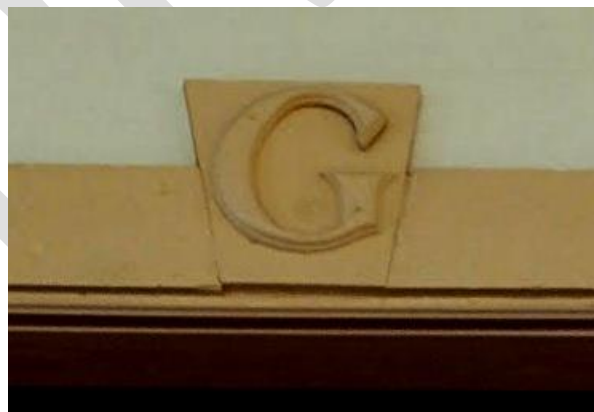
Keystone "G" over curved stage opening

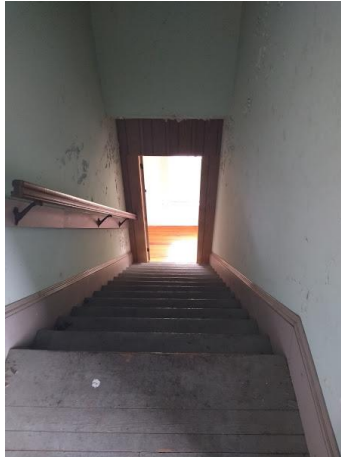
Stairway to second floor looking down from second floor

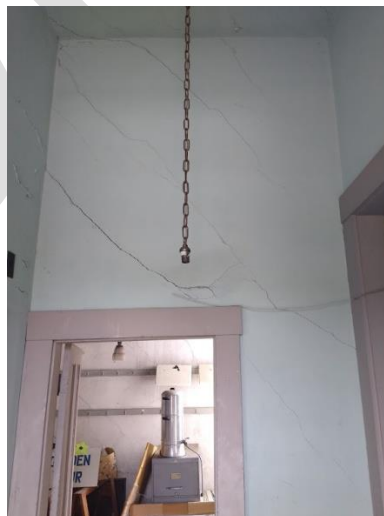
Stress cracks in plaster in landing at stairway looking south

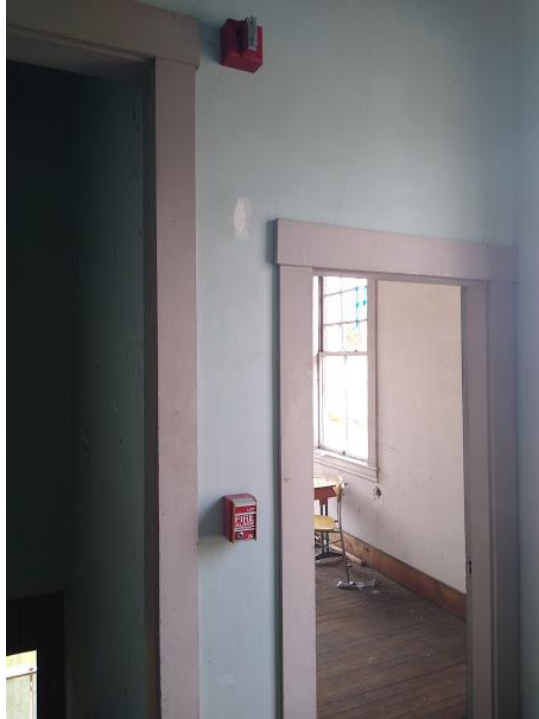
Hallway doorway from landing looking westerly

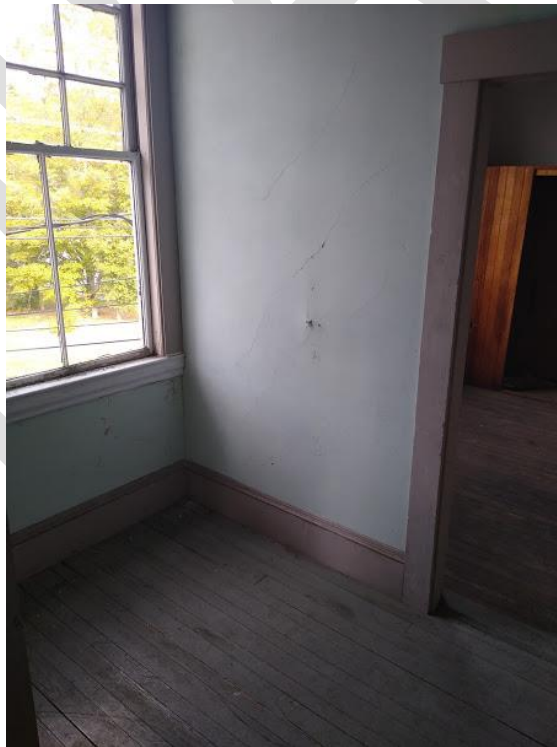
Stress cracks in plaster near doorway leading into Anteroom "B" looking east

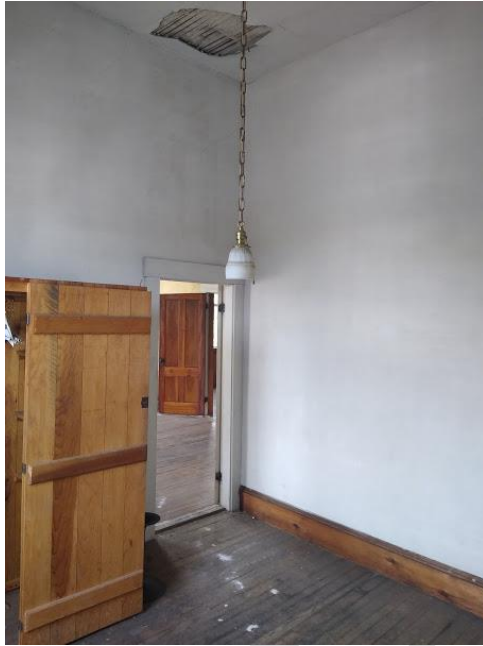
North Anteroom (Anteroom "B") looking from doorway of second floor landing
Note plaster failure in ceiling

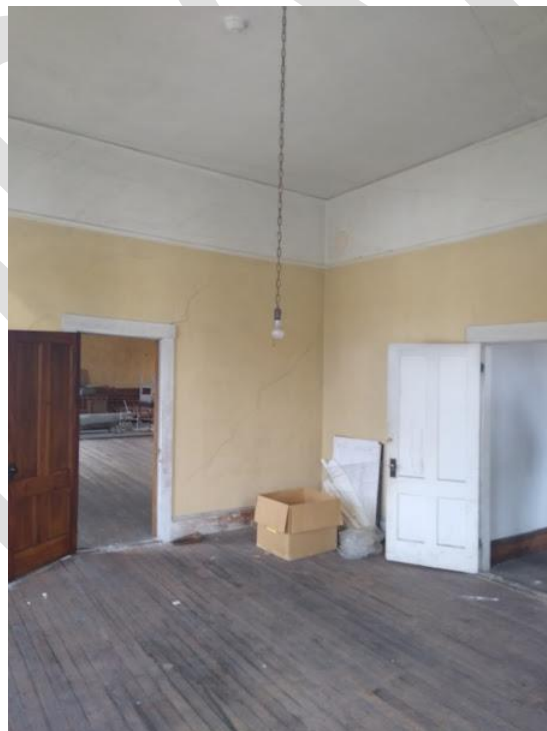
East Anteroom (Anteroom "A") looking south

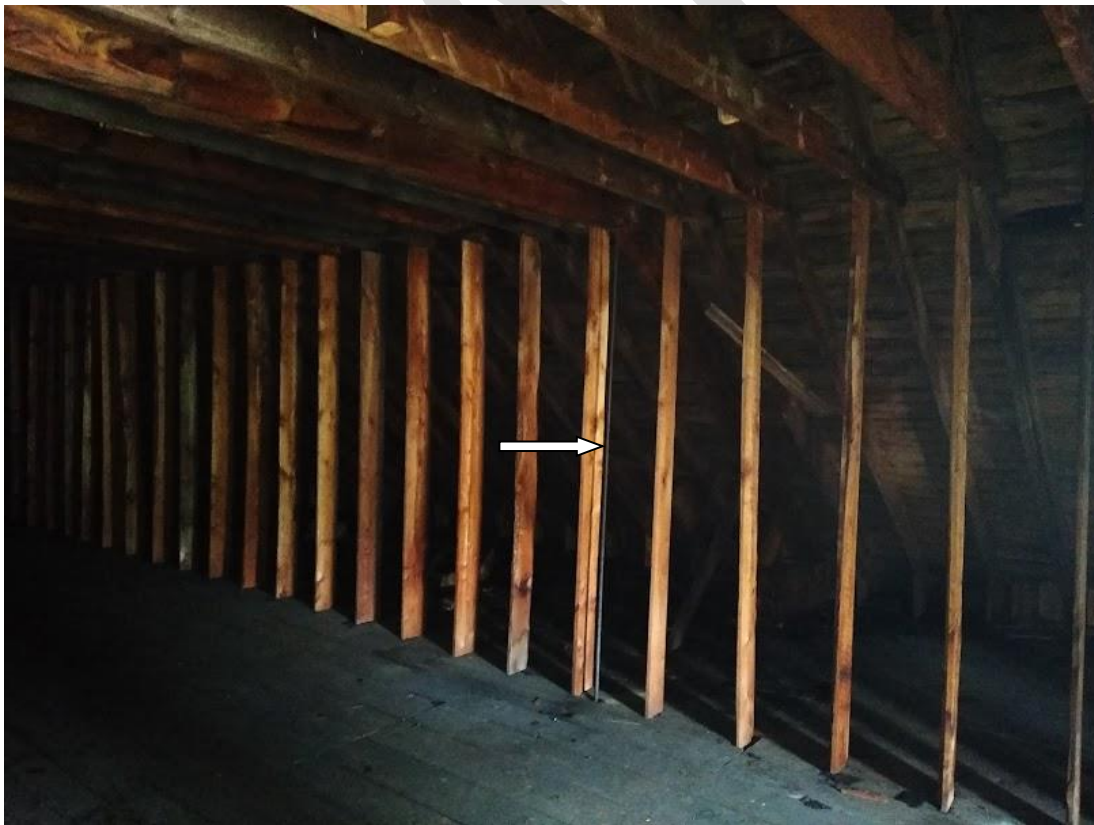
Attic framing looking southwesterly with added metal rod for partition support

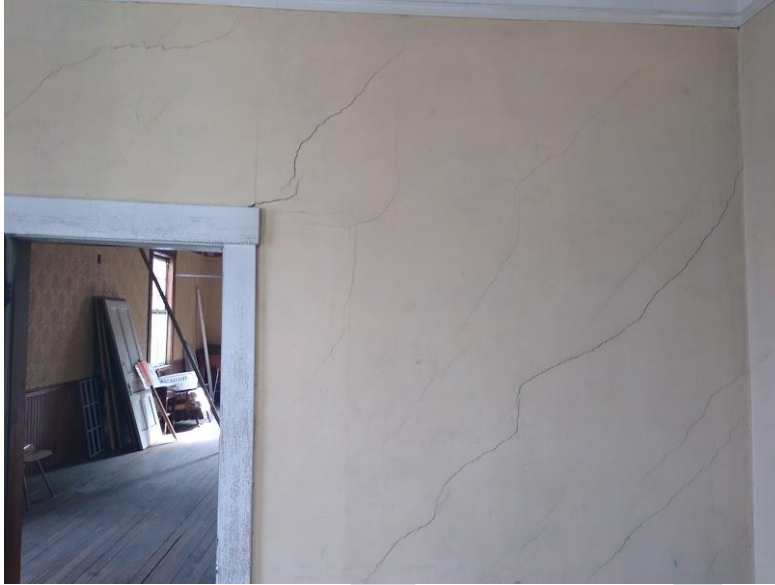
Close up of stress cracks in partition wall common with ceremonial wall
Cracks and sagging of wall due to lack of support across span.

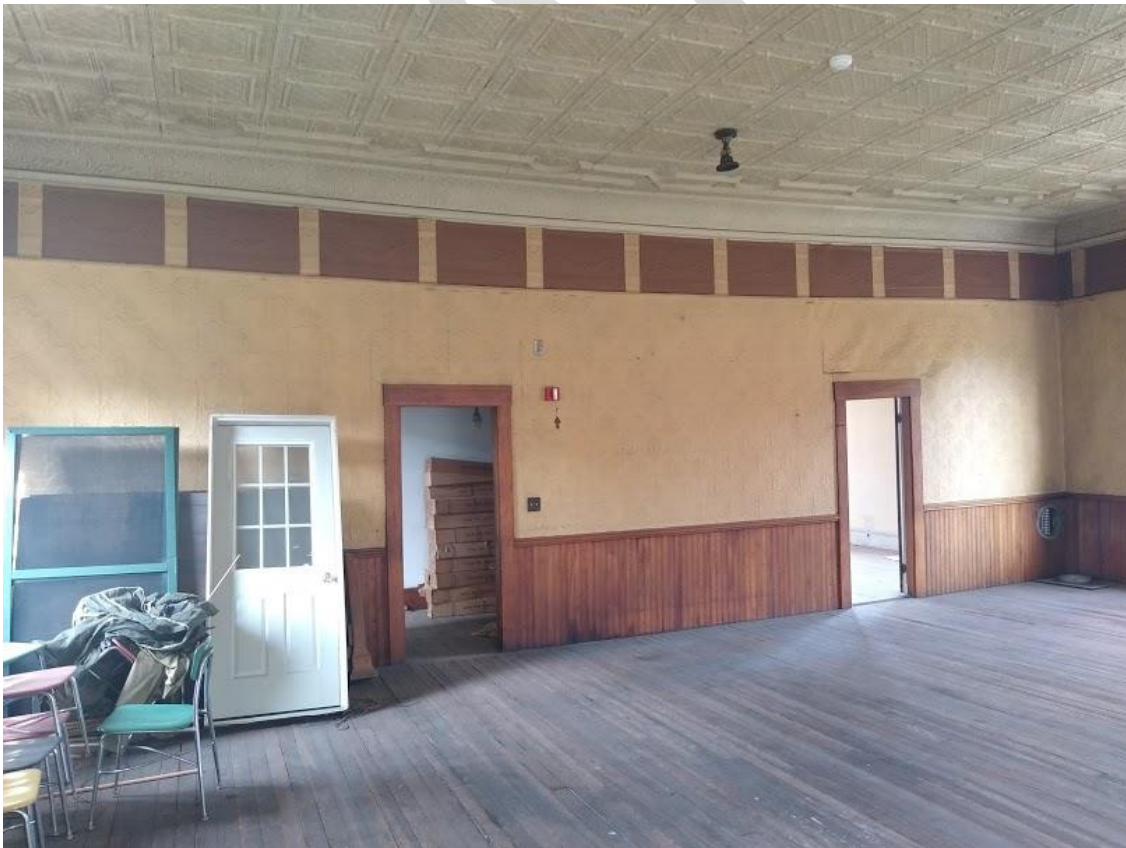
Ceremonial room looking north at sagging partition

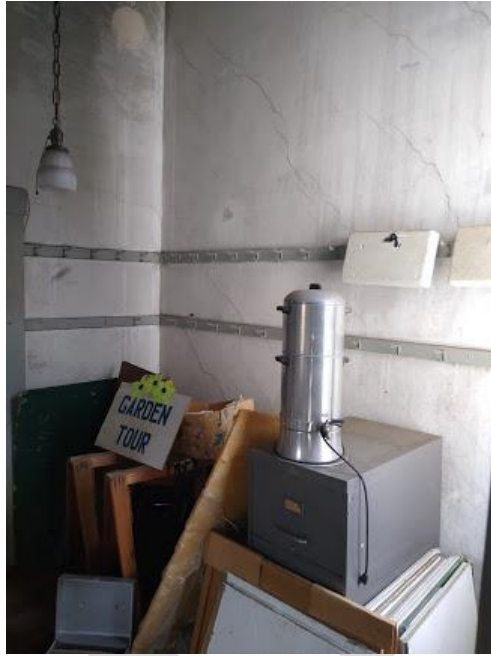
Anteroom (possible kitchen) looking south west, with stove connection on far right into exterior chimney (not seen in photo)
Plaster shows stress cracks

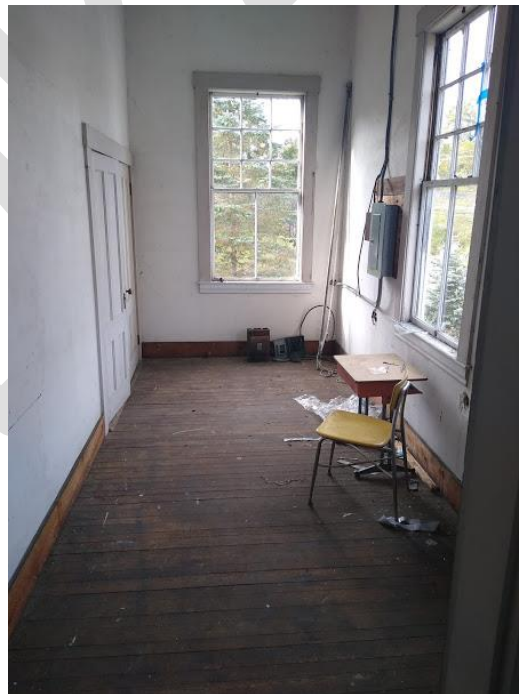
Hallway next to 2nd floor stairs leading to 3rd floor tower stairs

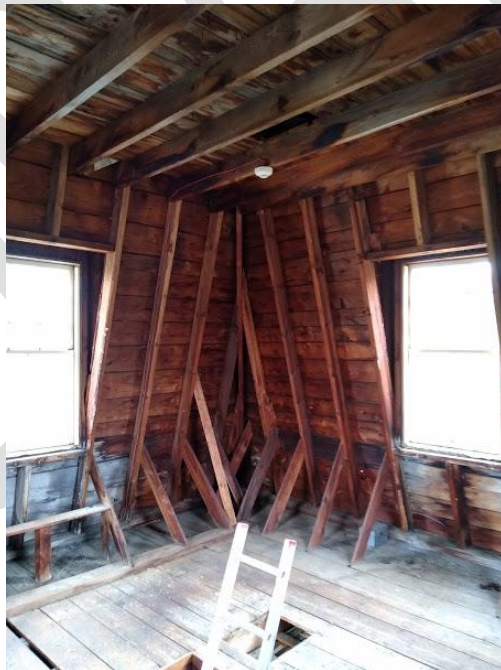
Unfinished attic space above tower room looking southeast
